CRITTER ALERT

Jane Christen, AMS®

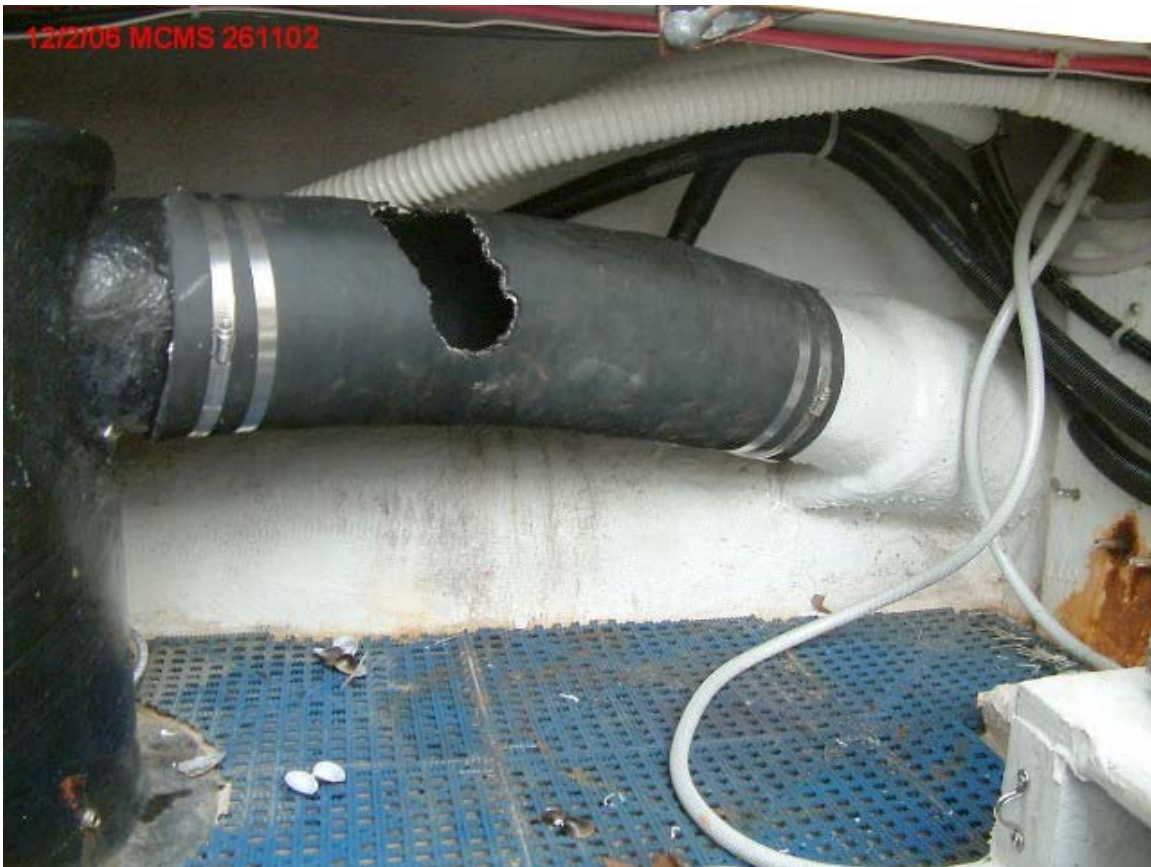
Any boat that has a wet exhaust with a discharge opening of about three inches or larger is at risk. A critter can and will swim up the exhaust hose and then chew through the hose to the inside of the boat.

The hole in this hose is 6.5 by 2.5 inches and the bottom of the opening is even with the static waterline. Note small clamshells deposited under hose.

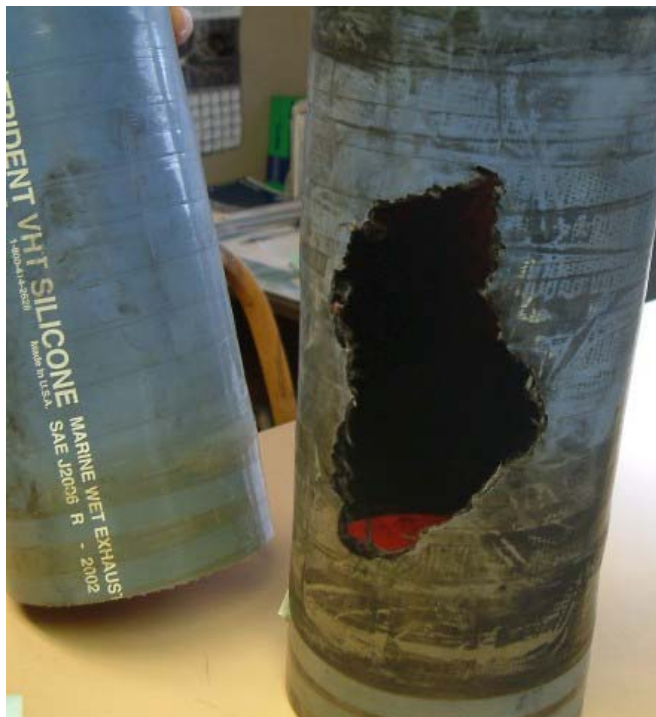
The critter usually chews through the top of the exhaust hose just above the internal water line. It is hard to believe that by using claws and teeth a critter can get a hole started in this very tough hose material.

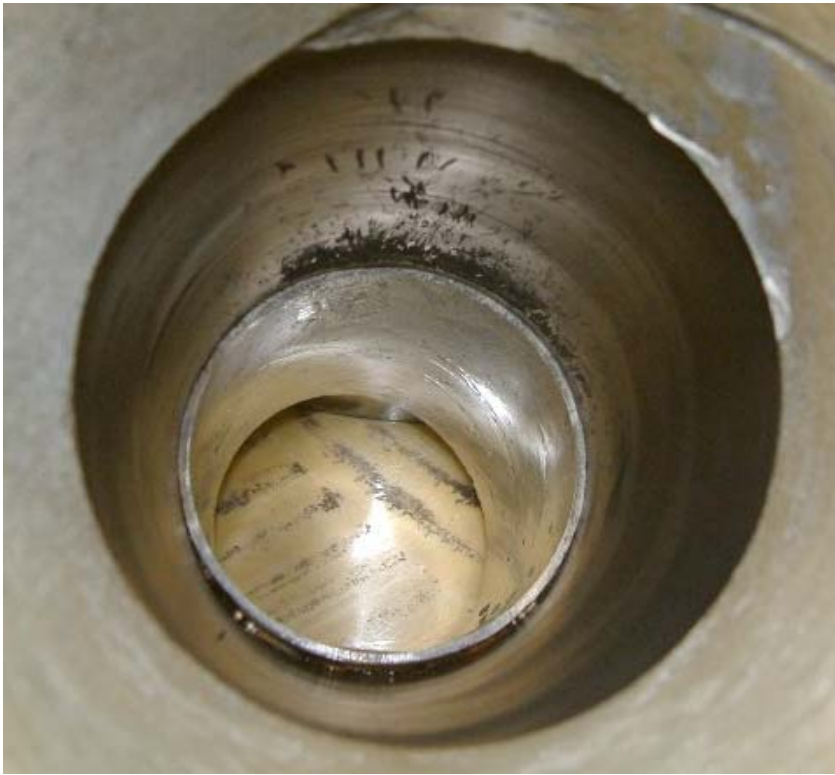
Whenever the boat is hauled, use a flashlight to look up the exhaust and check for indications of critter activity.

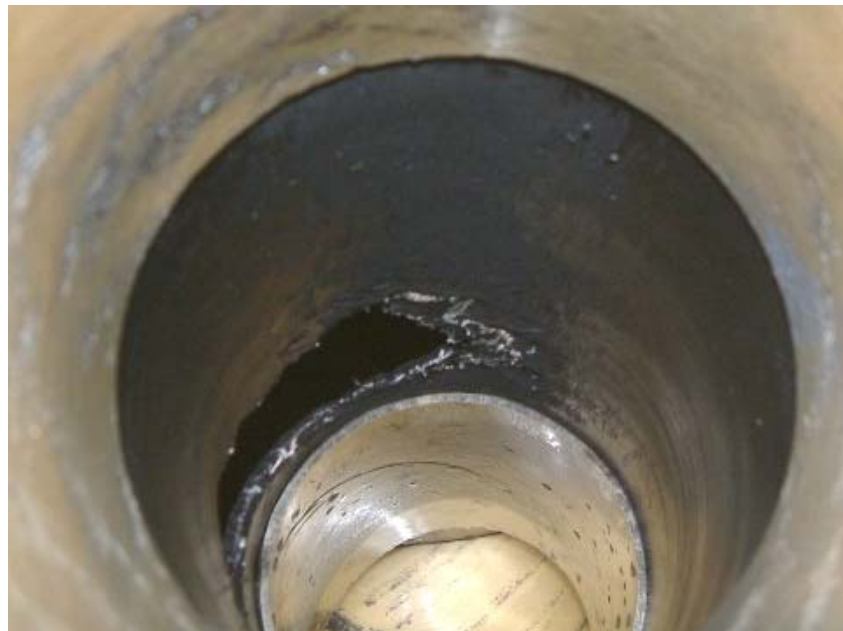
The structure at the forward end of these photos is the water lift muffler.

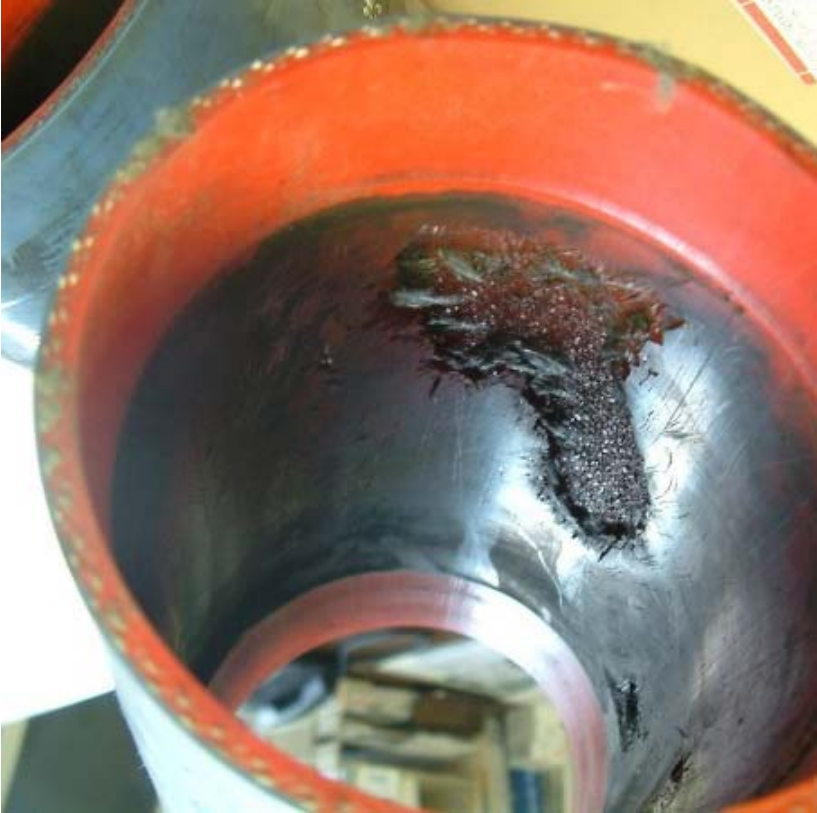
As visible in this photo, the critter often starts gnawing away at the inside surface of the hose over a period of time – without going through to the outside of the hose.

Because part of the gnawed away surface of the inside of this hose is blackened by soot, and other areas are less black, it is possible the engine was operated after the damage was started and the critter returned to do more damage at a later date.

Note that much of the interior layer of the hose has been removed all around the part that has been holed.

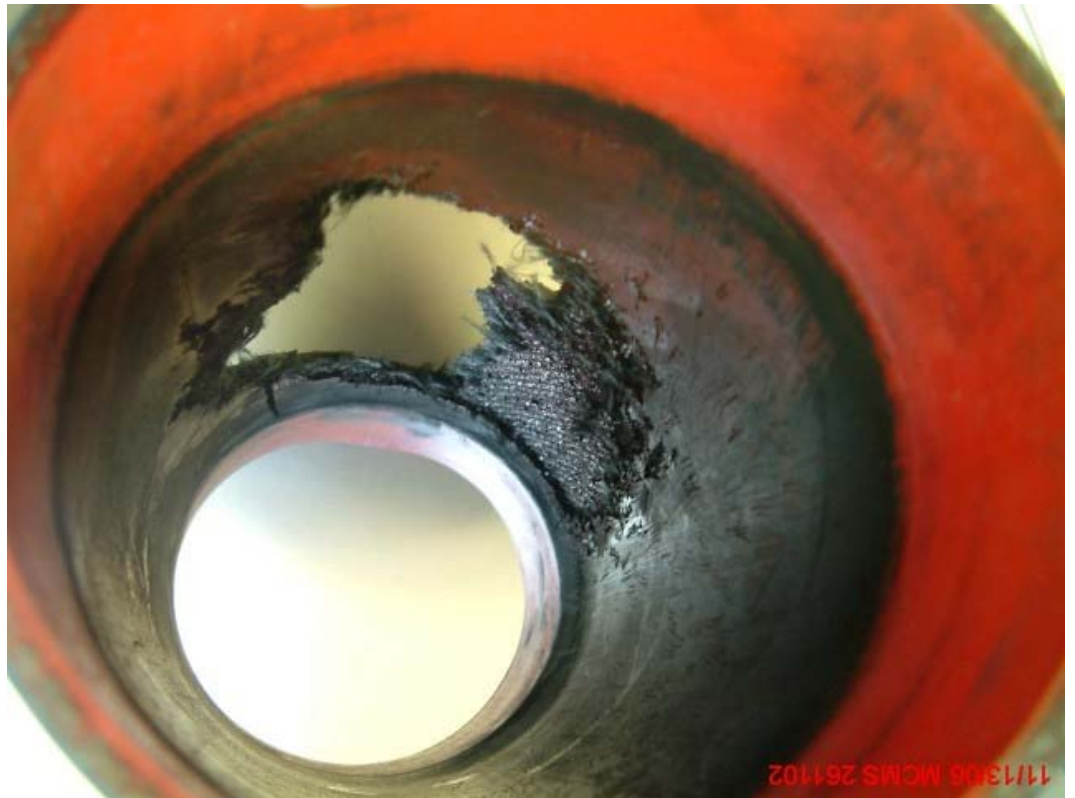
A variety of measures can be used to repel rodent invaders, including everything from window screen to barred fittings over the exhaust. Dunato's of Seattle, WA sells an adjustable fitting that installs inside the discharge pipe and is held in place by friction when the threaded bars are turned to extend the fitting.
